FATIGUE TESTING OF 70-30 COPPER-NICKEL

Gary Lee Rowe

December 1969

MASTER OF SCIENCE IN MECHANICAL ENGINEERING

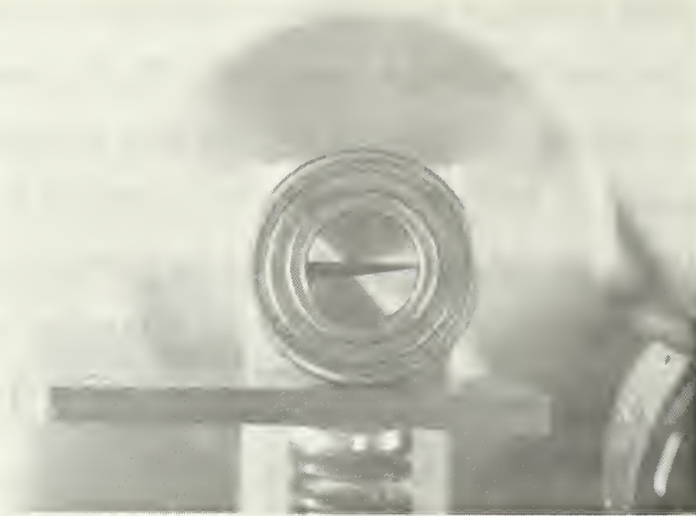
FIGURE 2. ARROW ON CAM IN NEUTRAL POSITION

position for all measurements was obtained by inserting an Allen wrench in the hole in the cylindrical surface of the flywheel and allowing it to bear against the underside of the belt damper plate. This is roughly indicated by the orientation of an arrow mark on the cam as shown in Figure 2.

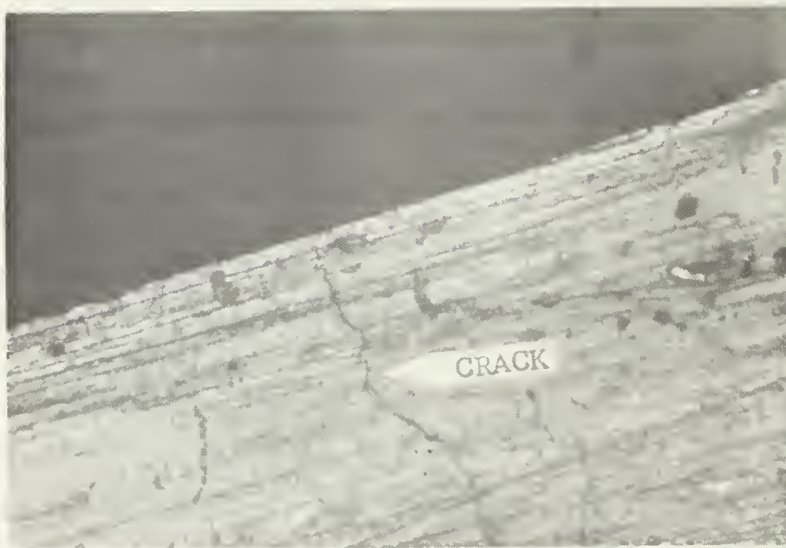
FIGURE 3. FIRST CRACK, SPECIMEN #4, 150X

Inspection of the specimen surface for cracks is a procedure which has to be conducted meticulously and without regard to time. A crack which might appear under one particular light angle often did not appear under another angle. By maneuvering the lamp to different positions and carefully examining the specimen surface under each lamp position, chances of crack detection are improved. Figures 2 through 9 inclusive, illustrate some of the cracks actually detected on individual specimens.

In taking these photographs through the metallograph, the Solder Stop coating was left intact in an attempt to illustrate how this coating accentuates the cracks. With a crack detected, the resistance change at that number of cycles was recorded and the test terminated.

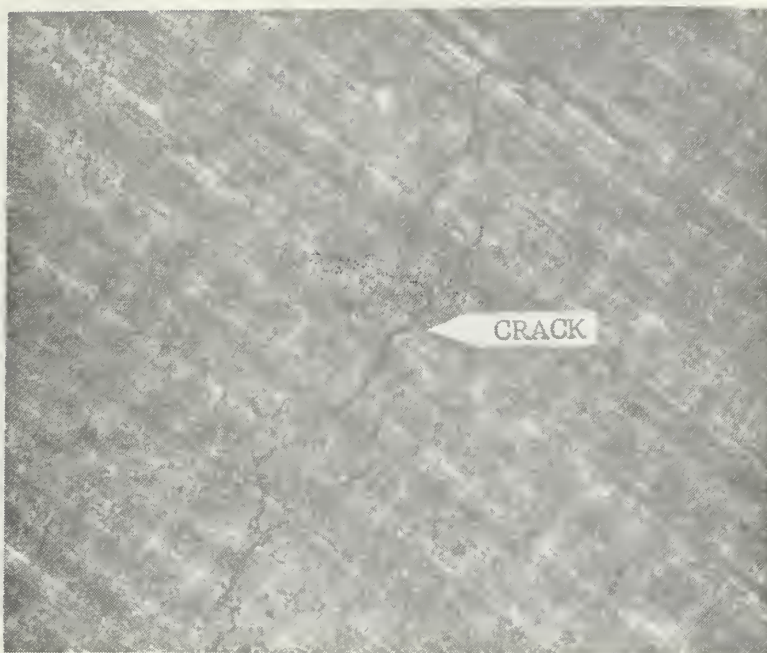
FIGURE 4. FIRST CRACK, SPECIMEN #6, 150X

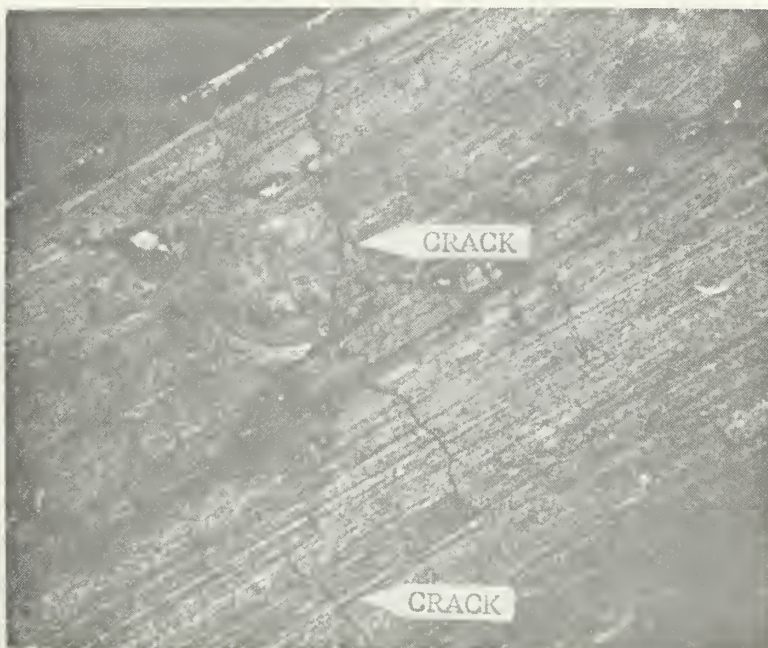
FIGURE 5. FIRST CRACK, SPECIMEN #8, 100X

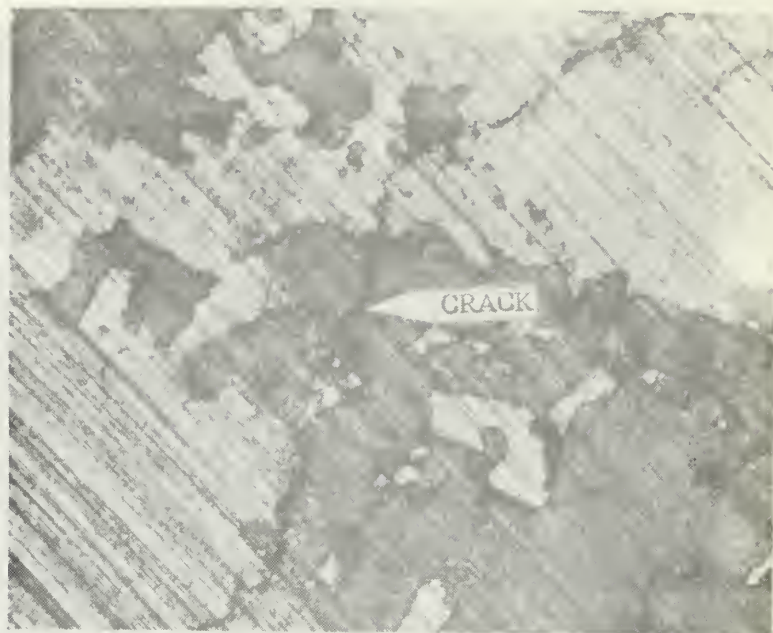
FIGURE 6. FIRST CRACK, SPECIMEN #7, 150X

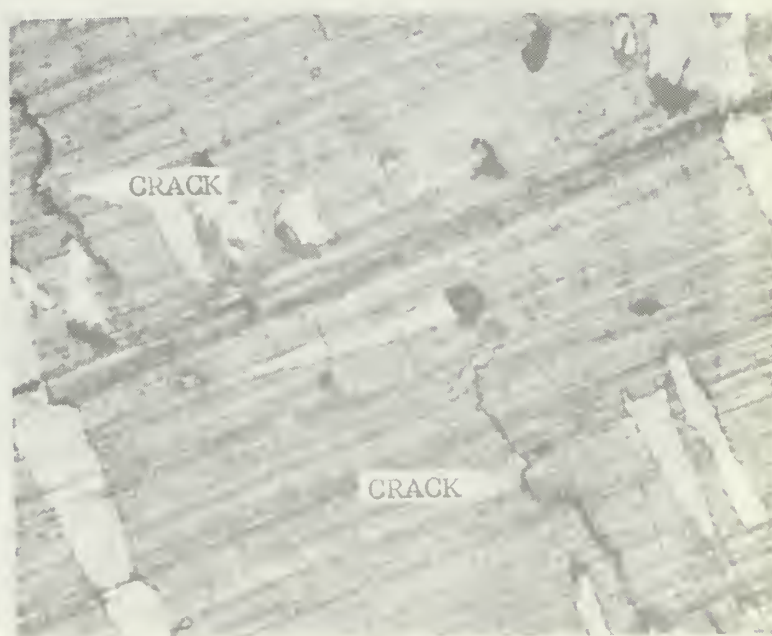
FIGURE 7. SECONDARY CRACKS, SPECIMEN #7, 150X
